CQWW @ VP5DX October 2015

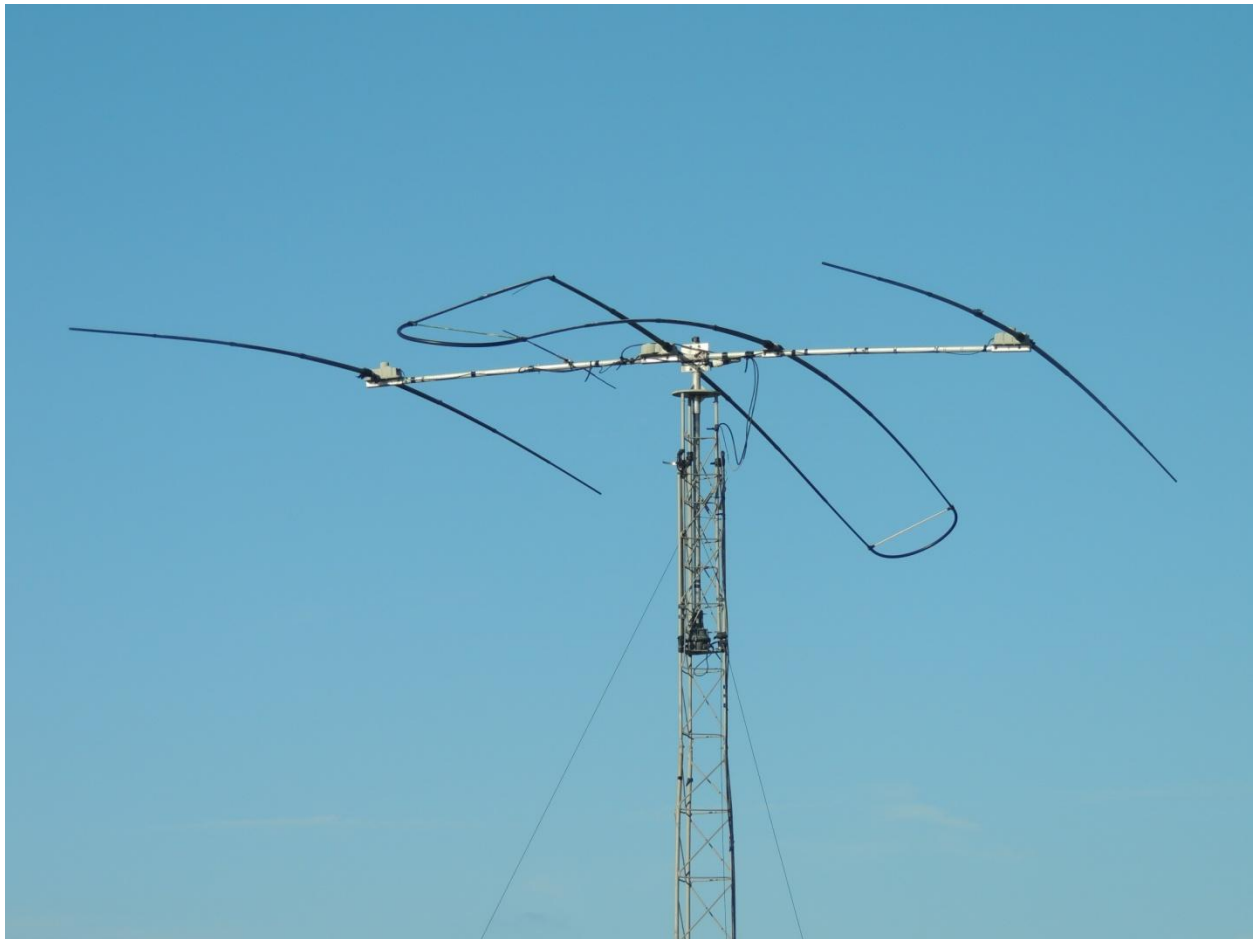
The house is in a resort location and only the main tower and antenna can be left installed when the station is not being used. For the last few years the location has only been used during the CQWW phone contest in October. The main antenna on that tower is a 3 element SteppIr with the 30/40 meter dipole kit. This antenna was installed in 2008 and was taken down once for tower maintenance and the element poles were painted at that time. This was about 3 or 4 years ago. In early September of 2015 we received a picture from the neighbor saying that it looked like the antenna was broken and we might need to bring parts to repair it when we came in October.

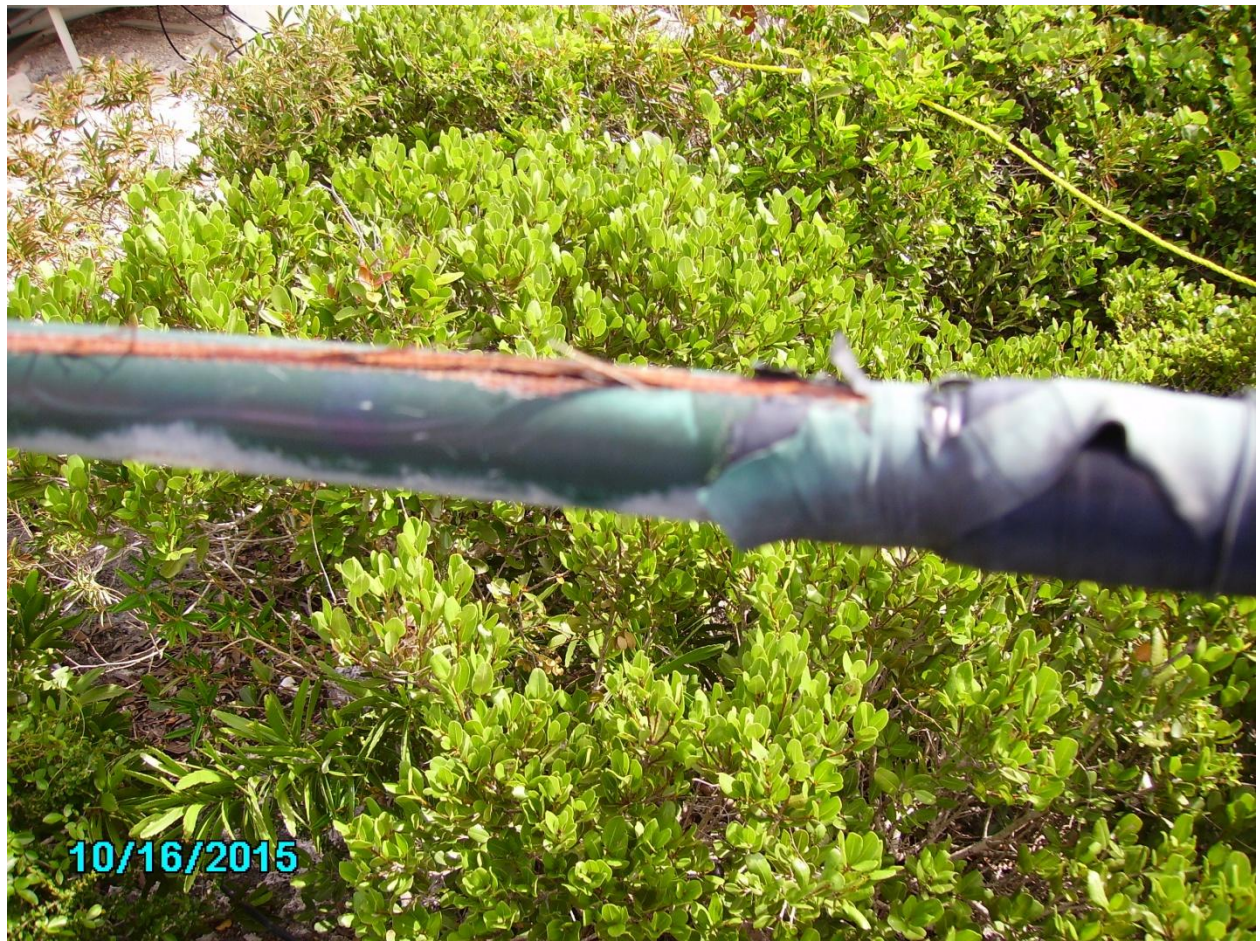
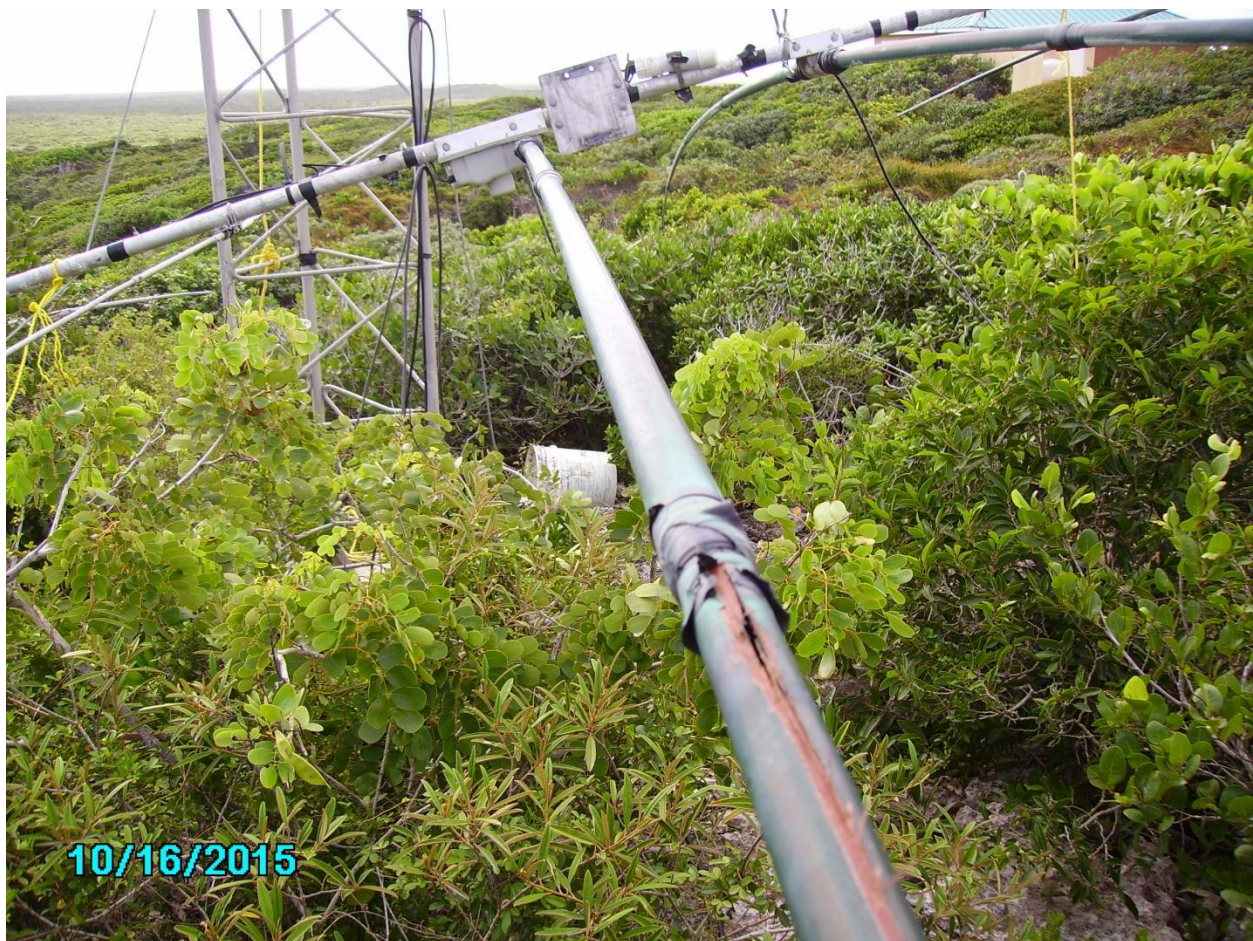
After lowering the antenna to the ground, here's what the tube looked like.

A new tube was purchased and shipped to Providenciales for us to pick up on our trip. Upon arrival and settling in we proceeded to take the antenna down and make repairs. We had not spent any time in the radio shack at this point as there were no antennas to use anyway. When we leave the station after a contest there is a check list of things that are always, ALWAYS, done. Everything is unplugged from the ac power, any cables from the rotor, SteppIr control lines, any coax runs are removed from their respective control boxes. This includes retracting the elements on the antenna and leaving the rotor in the north position.

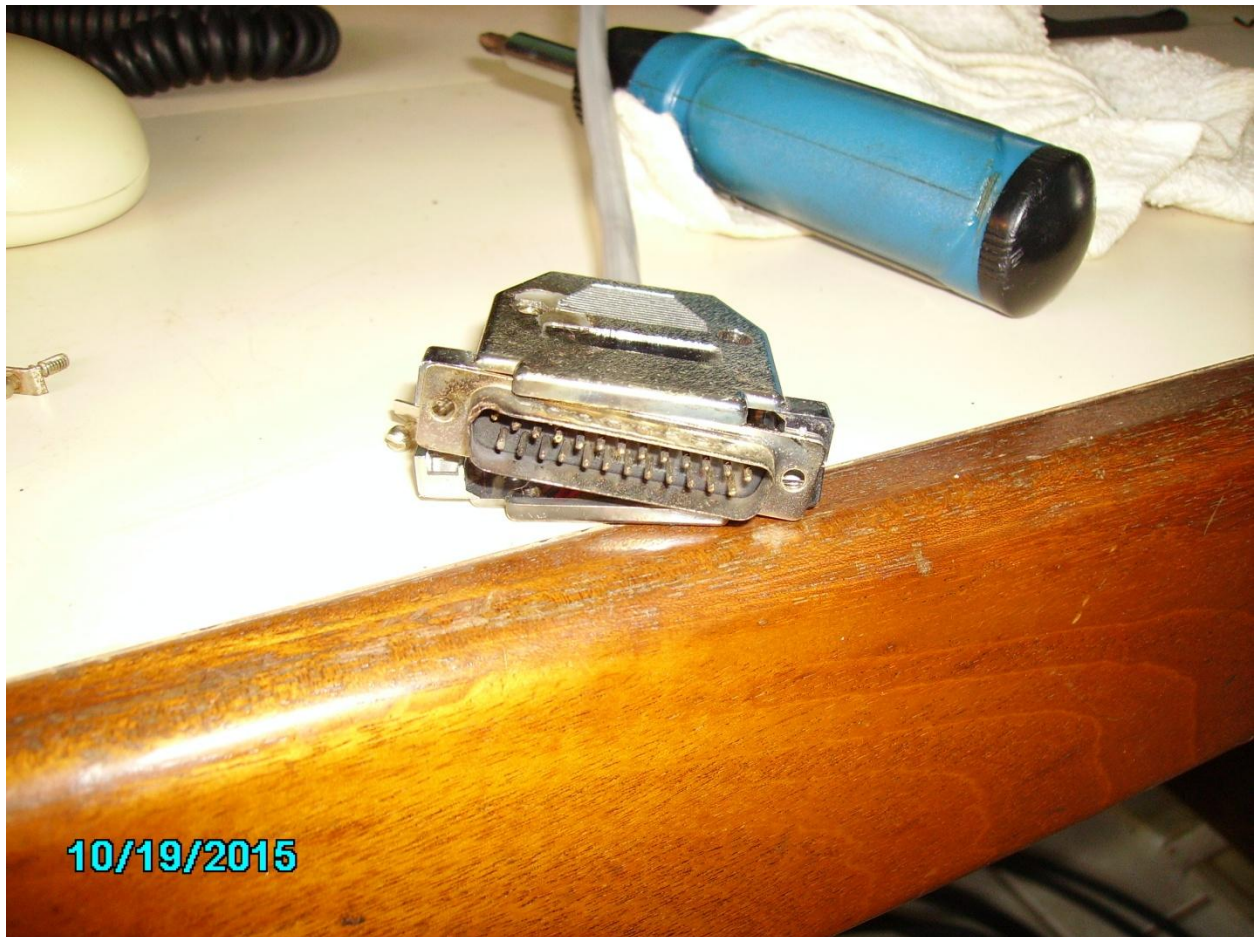
Also when removing the tubes, we found one of the tapes on the driven element was not retracted so I proceeded to go inside the shack plug in the SteppIr controller and park the elements. When I got inside and put power to the controller it did not come on. A quick check of the power supply showed it was dead. Also the control cable from the antenna had a burned mark on it. There was also a black mark from where the cable was laying not plugged in to anything to the case of the Icom 756 Pro and another black mark from that case to the case on the SteppIr control box. We knew at this moment that there is more to this operation than first thought. We had the power supply from the old SteppIr control box although it had not been seen for 7 years. After opening dozens of boxes in storage and finding that, the Control unit still did not power up. A couple of weeks before NF4L gave me a motor control PCB for this model control box and opening and inspecting found the regulator on our box was bad. The new pcb was installed and the box came up and appeared to be working. Of course it would not control the antenna as we needed to find a DB25 male connector to replace this one.

Before looking for a connector to replace this one with burned off pin at #1 I decided to check the resistance to the motors from this end of the cable. They were open on the couple I checked, and it was thought that maybe the cable was cut or blown open somewhere. All goes downhill from this point. No breaks were found in the control cable right up to the antenna. But during this inspection we did find the coax was missing about a foot of shield and its' insulation.

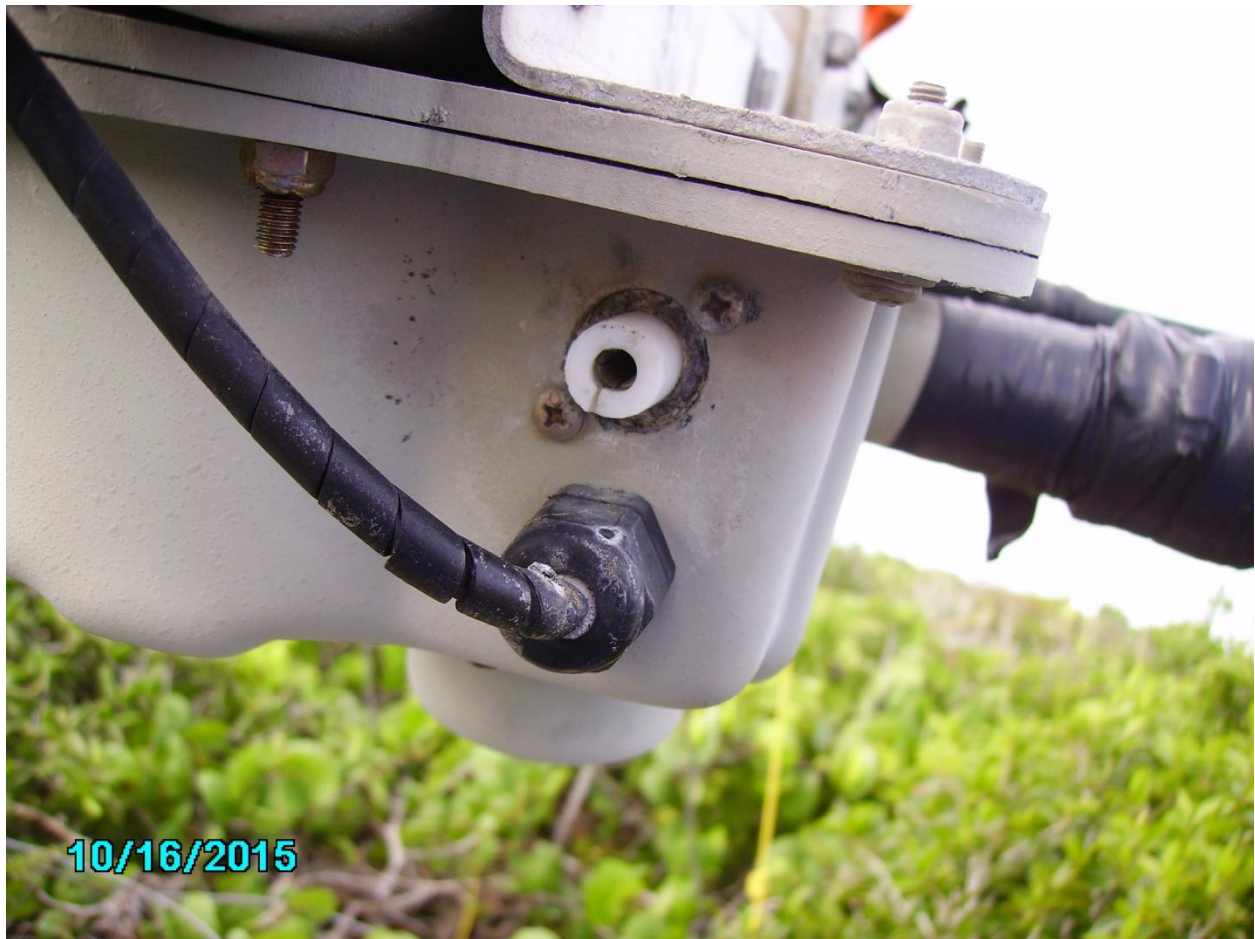
I cut back the coax towards the shack about 2 feet and found the cable to be very clean and not damaged so a new connector was installed, and another new piece made to go up to the antenna with a PL-258. When we tried to remove the PL-259 from the driven element of the antenna this happened.

The shell of the PL-259 came off with the threads of the female completely. Well this could be fixed anyway. We took the EHU off the antenna and proceeded to put it on the picnic bench to make repairs.

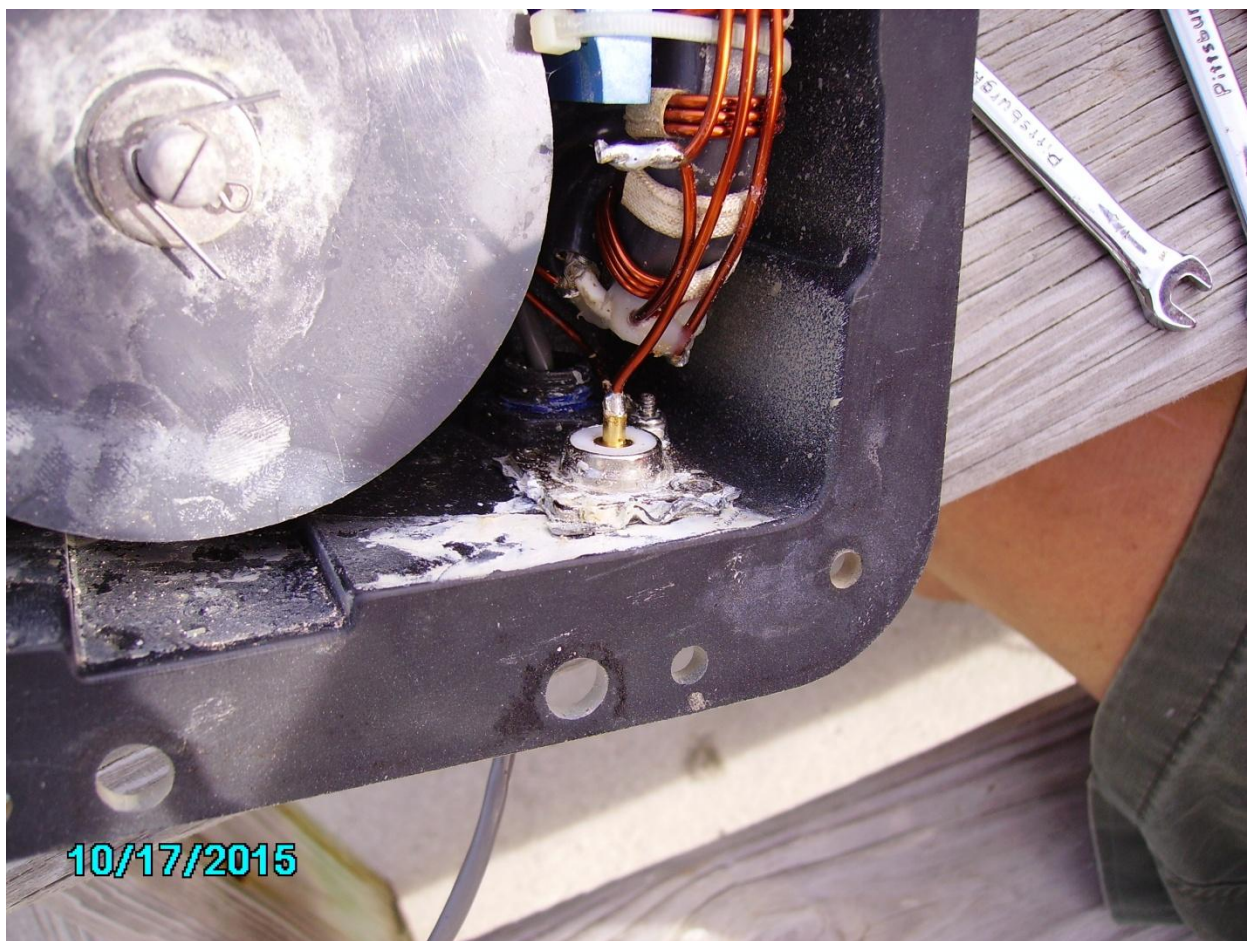
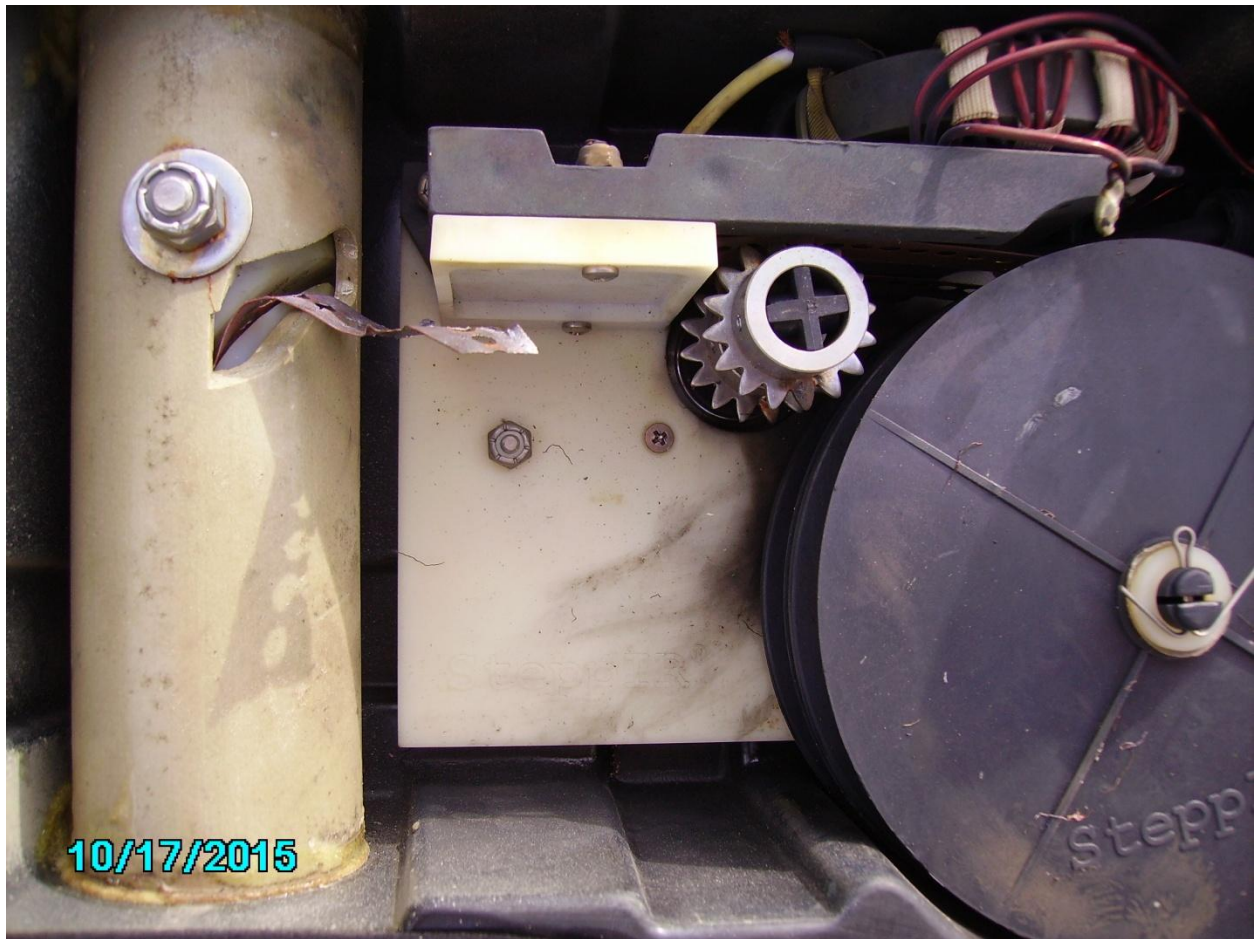
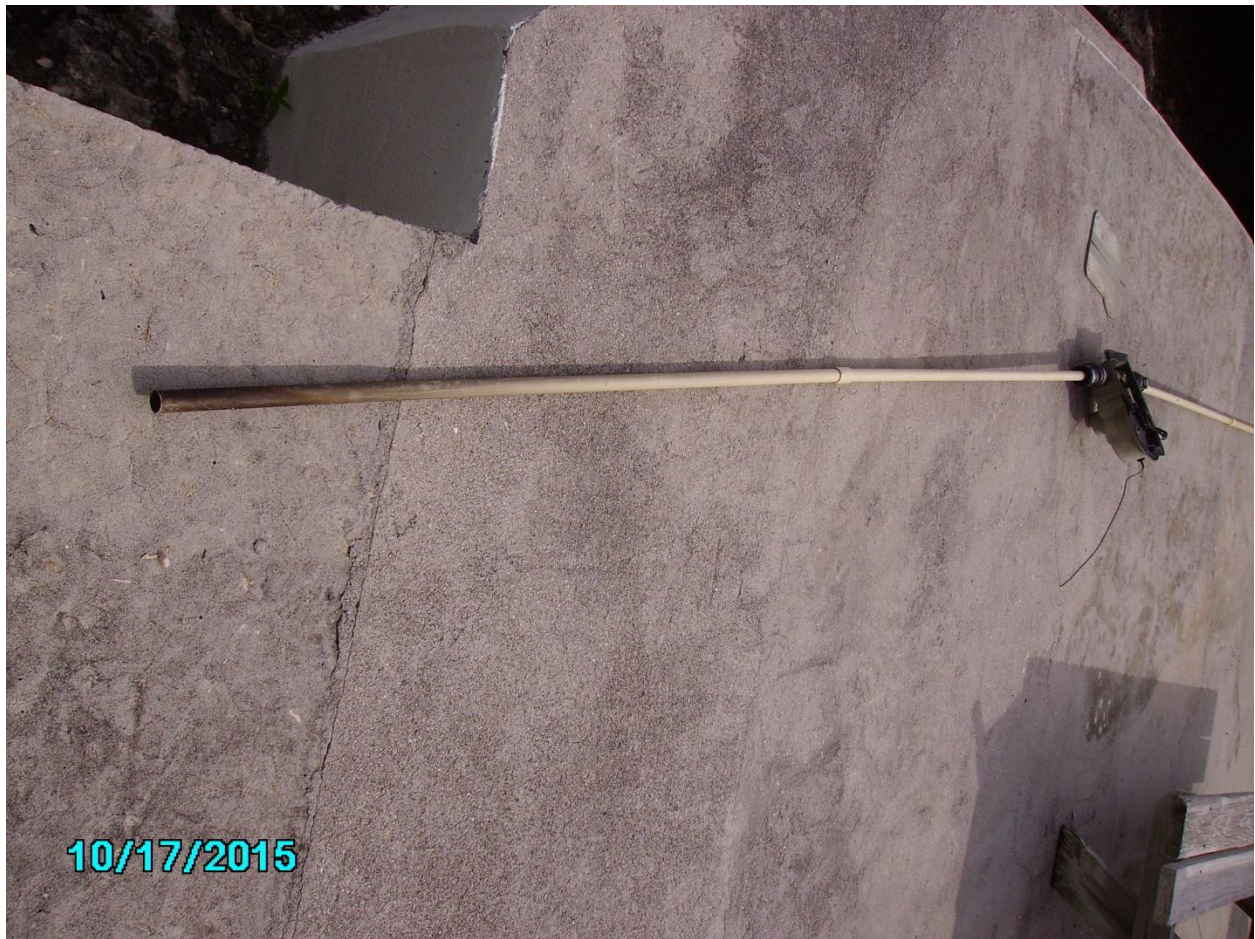
Opening the EHU found this damage.

The tapes are burned in half, both of them even though only one was not extended. Also notice the burned area on the end of the element that had not fully retracted. Ron hunted around and found the EHU from the old antenna and we made the decision to make this into a 20-6 meter antenna and we had enough parts to do that. The driven element EHU from the original antenna was not damaged and it was saved. The other 2 EHU's from that old antenna were destroyed when the tower had come down in 2008 and broken the housings. Of course when he went to remove the coax connector on the old EHU, the connector twisted off just like the other one.

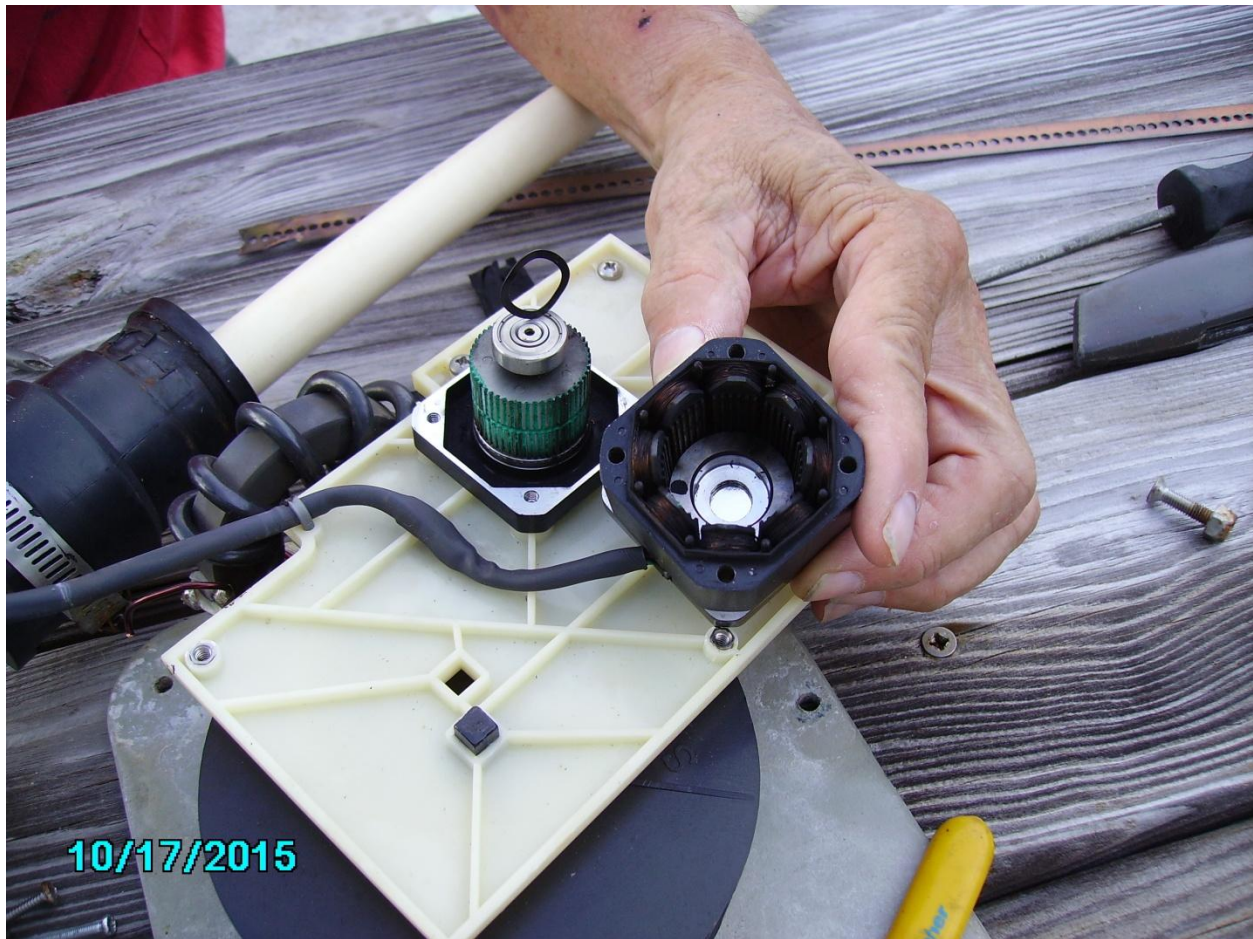
Now back to the control cable problem. I took the ohm meter out to the antenna to check the cables. I found that 3 of the other 4 windings on the stepper motors were open. We opened a stepper motor just to see what is inside.

The windings are burnt, along with the rotation unit. (Notice the end of the burnt tape on the bench)

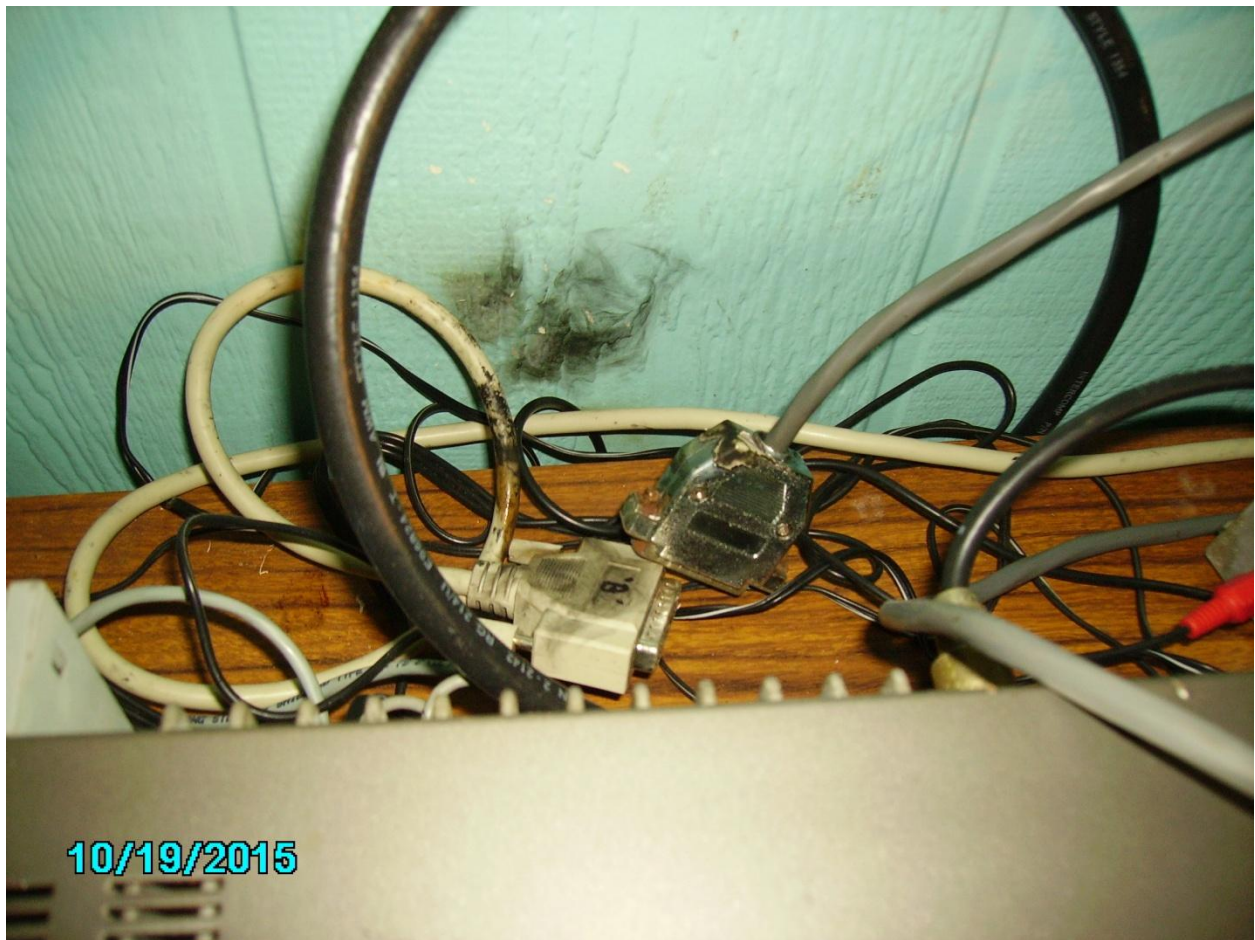
During all of this one of the monitors was flickering so bad that Steve could not read it on the computer being used upstairs to get the internet. I took it apart and replaced a couple of capacitors and it got a lot better. I then went over and turned on the TS-950 on the other bench. It came on but no frequency display. Moving it away from the wall to open it up here is what we found.

The white cable is a connector to the logic unit for the 10 position antenna switch; this logic unit was not connected to anything except another cable just like it over to the other operating position. The gray cable with the silver connector goes down to the filter box with 6 – ¼ wave stubs in it. The black cable going out to the left goes to the interface unit on the Kenwood to a USB input on the computer. Here is the USB to RS-232 interface from the Kenwood.

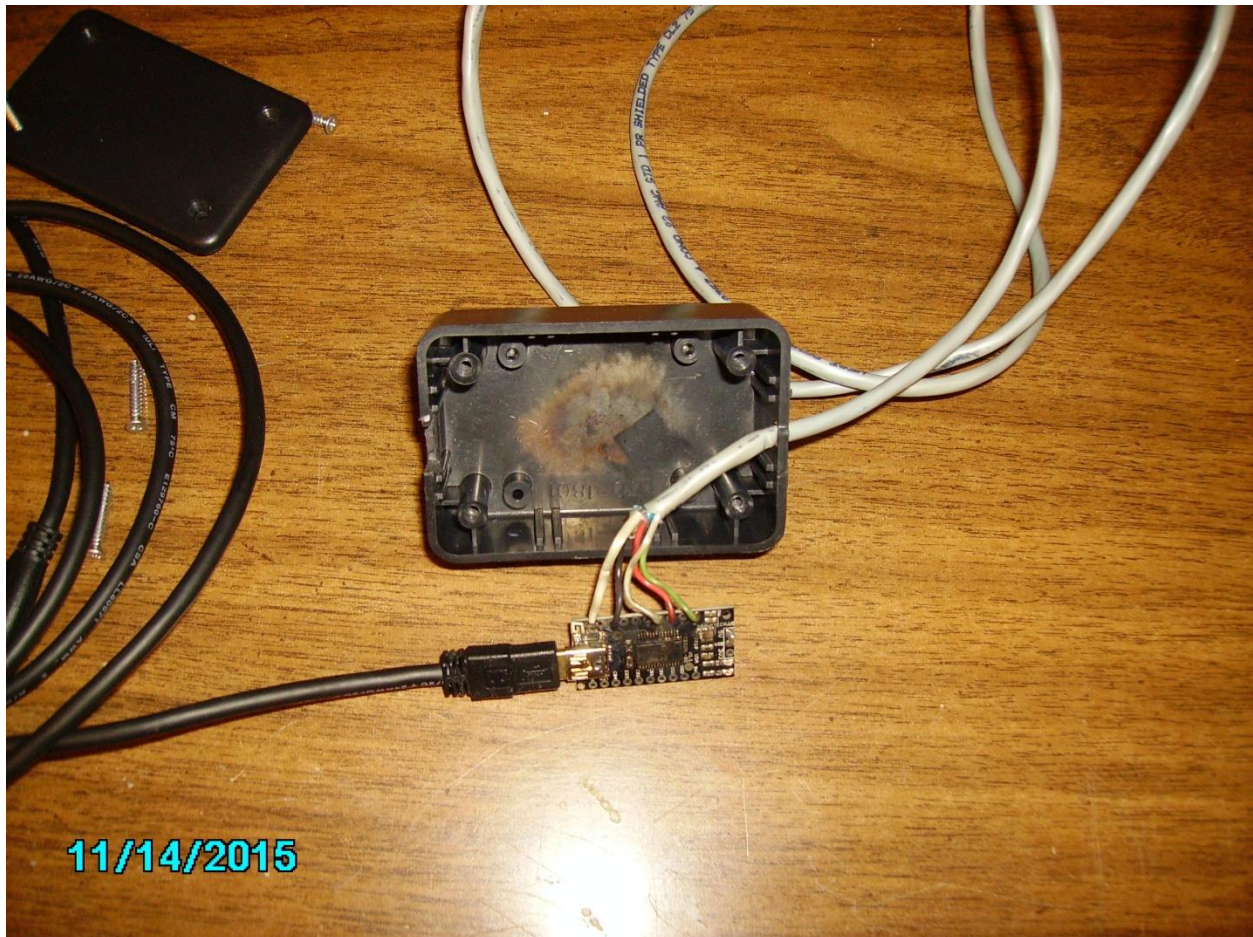
Not very surprising that the Kenwood's micro is dead and the mother board on the computer it was plugged into was blown up also. So 2 radio's out of commission. We pulled out our other TS-950 that was still in its shipping box from 2014. We never took it out the box last year as we used the Icom instead of it. We also pressed the old TS-930 into service. No computer control on it so we would have to remember at least to change bands manually in the computer. We had an original Kenwood IF232 that was stored away and connected it to the XP machine. Never got it working reliable, the computer would either talk to the radio or the radio to the computer, and sometimes it worked both ways, never did figure that out. While sorting that stuff out the old Cushcraft A3 was installed. Back in 2013 this antenna did not work, Mike and I spent a whole day taking apart all the traps and cleaning and refurbishing them. It worked fine until during the contest the SWR went sky high and failed again. Of course it did not work now either. Mike and I started pulling apart the traps again, inspecting and cleaning as necessary. After pulling 3 of the 4 traps on the driven element apart and finding nothing that even was dirty or making a bad contact we almost stopped. When pulling apart the final 15 meter trap we found this.

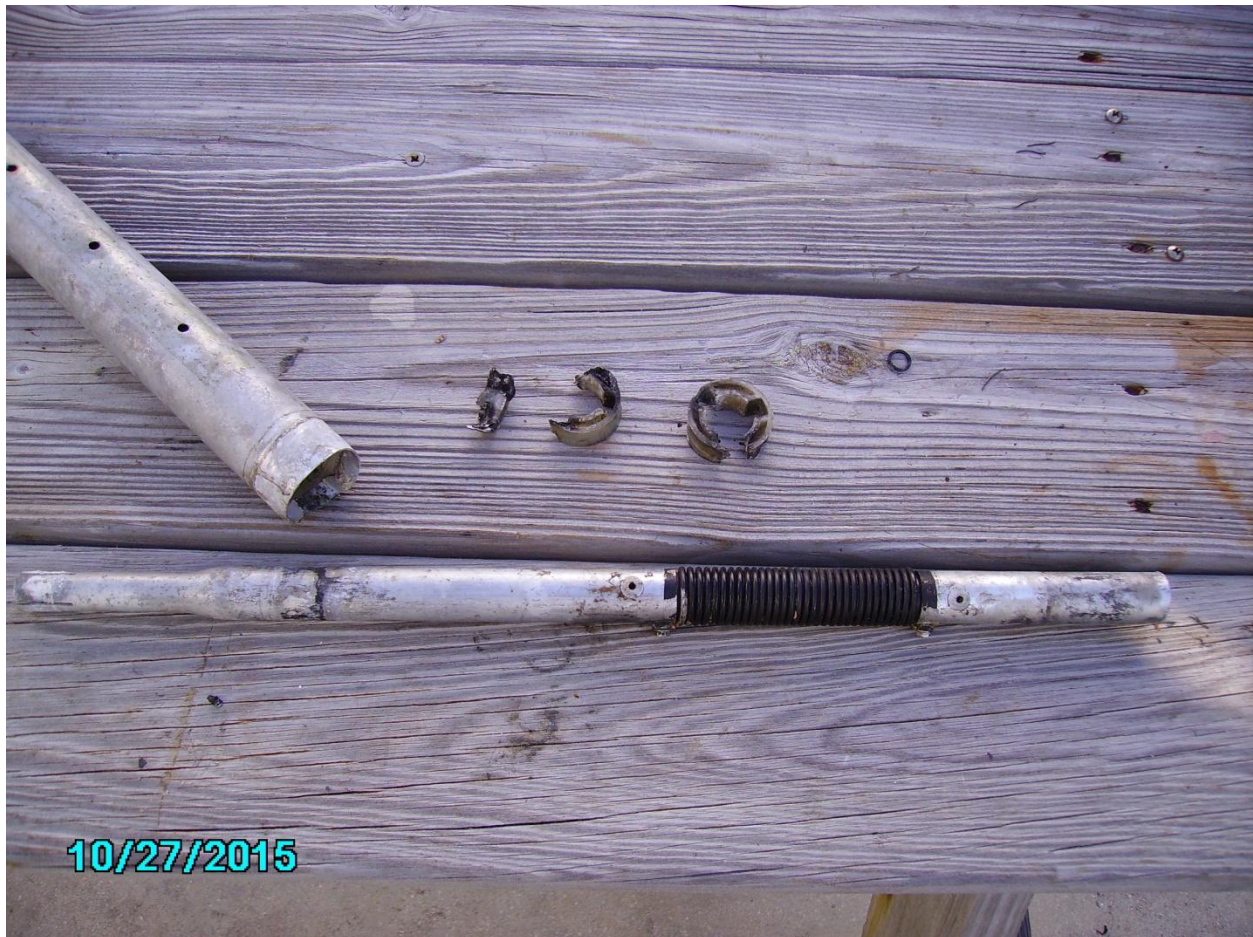
The insulators were burned up and it was black from the arcs. We blew the antenna up during the contest. Might be too much power, or might have been moisture inside of it. We don't know but it might explain why one of the AL-1200's band switches was burned up and had to be replaced in 2014. We repaired the trap, installed new insulators and the antenna works again.
