CQWW @ VP5DX October 2015

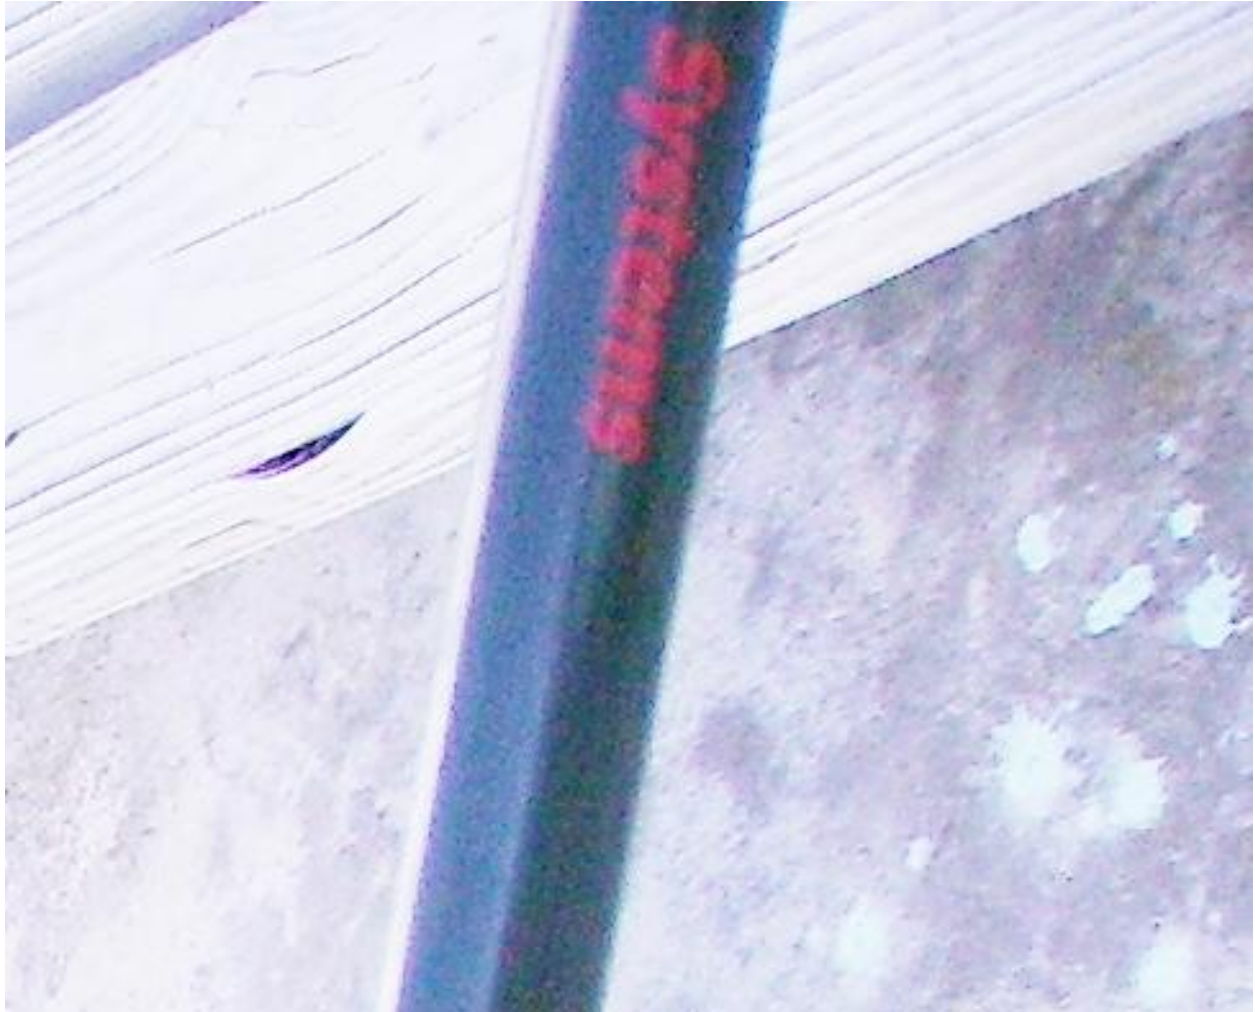
I dropped a note to SteppIr and asked what I needed to make the repair. They needed to know which fiberglass elements we had as they have changed suppliers from time to time and the capacitance could be different. Lucky I found a picture of the element when we originally installed the antenna in 2008 blew it up and the label was visible. This SteppIr was a replacement for the previous 3 element that did not have the 30/40 meter kit and was damaged from a hurricane that took the tower down in September of 2008.

A new tube was purchased and shipped to Providenciales for us to pick up on our trip. Upon arrival and settling in we proceeded to take the antenna down and make repairs. We had not spent any time in the radio shack at this point as there were no antennas to use anyway. When we leave the station after a contest there is a check list of things that are always, ALWAYS, done. Everything is unplugged from the ac power, any cables from the rotor, SteppIr control lines, any coax runs are removed from their respective control boxes. This includes retracting the elements on the antenna and leaving the rotor in the north position.
